**ABOVEGROUND STORAGE TANK
INTEGRITY TESTING SURVEY**

HAZARDOUS WASTE TANK 78

ELAN CHEMICAL COMPANY, INC.
268 DOREMUS AVENUE
NEWARK, NEW JERSEY 07105

MARCH 11, 1997
TTI PROJECT NO. 97-170

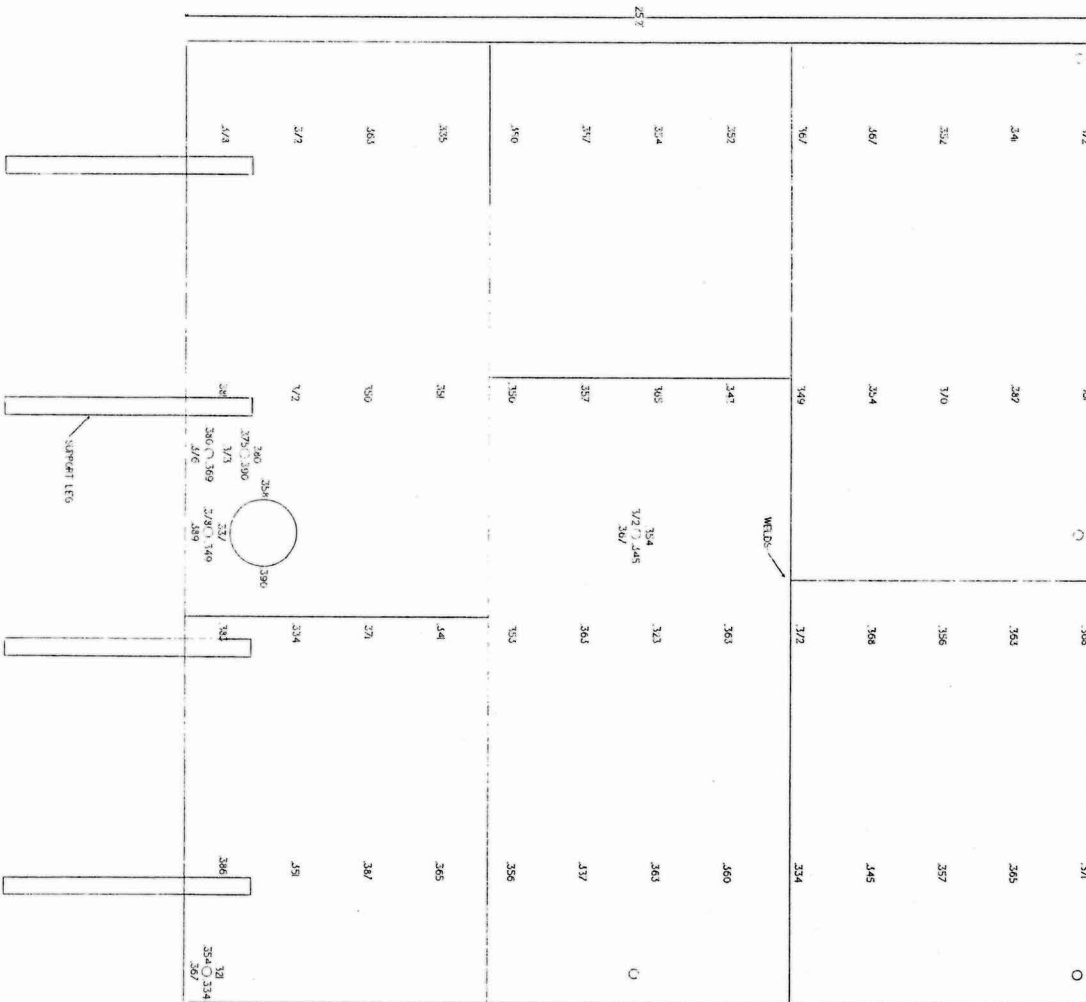
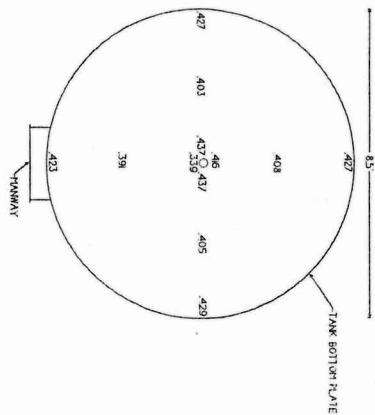
TANK SCHEMATIC DIAGRAM & UT DATA
DRAWING NO. TANK 78

Thickness data recorded for Tank 78 exceeded API 653 and NJDEP criteria for AST shell thickness. All data is presented on a schematic diagram of Tank 78, included in Appendix B.

*Dented area appears in
good condition. Location on
diagram.*
